**SITE VISIT TO OBSERVE AND VERIFY
PHYSICAL DETAILS**

*Supporting Producers to upgrade Processing Infrastructure to
Obtain GMP*

Technical Report

Submitted to UNIDO – WTO – TSC Project

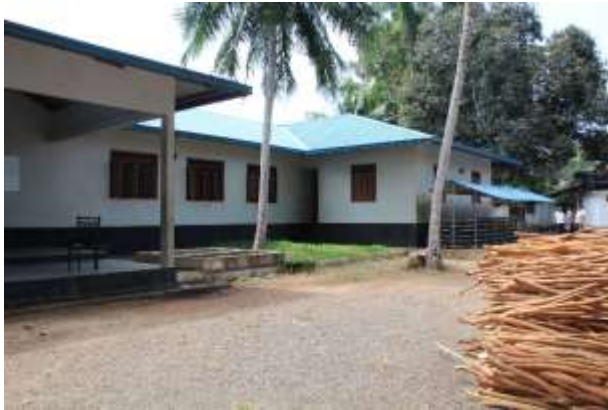
Figure 1. Front elevation view (part of building from left side)

A firmly and extensively built premise with physically separated components for processing, worker changing and resting, and toilets. Critical physical requirements for food safety compliance were present. Basic facilities for workers were also present.

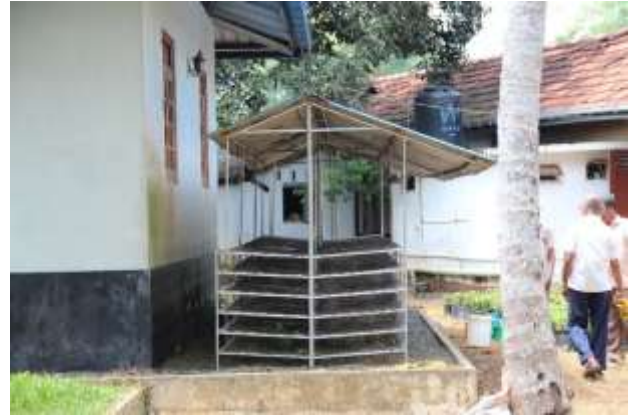
Figure 4. Outside drying racks

10. Replacement of drying rack from the existing position to a suggested place.
11. The premise did not have a boundary fence. Therefore, suggested to build a half-wall wire-mesh fence surrounding the premise.

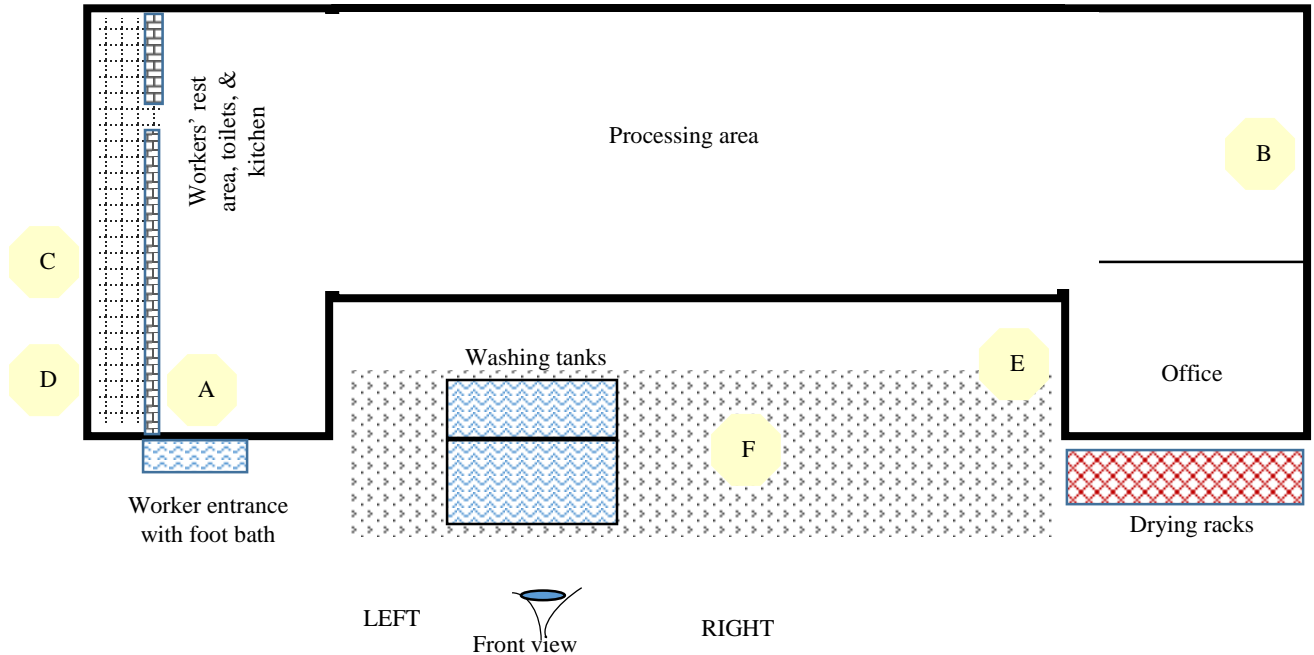
Figure 5. Sketch of building floor plan (not drawn to scale)

All observations and recommendations are referring to Figure 5.

1. Mark A: Worker entrance. Length of foot bath was not up to standard and should be extended up to a length exceeding two strides of a worker. The entrance was exposed to outside and susceptible to dust; therefore, should fix a plastic curtain.
2. The premise did not have an outlet for removing peeled cinnamon wood and scrapped outer bark. Therefore, it is recommended fix a roller window at point of wall that is mark as B in the sketch.
3. Gap between premise's wall and roof was open thus, susceptible for intrusions of animals into processing area. This gap to be fill-up with plastic mesh.
4. Mark C: There was a door on partition wall between the processing area and workers' rest area. Keeping this door compromises hygiene of processing area thus, it to be filled and sealed. A sealed glass window to be fixed on this partitioning wall.

5. Present entrance to the workers rest rooms, kitchen, and toilet area was not appropriate and thus, to be changed to point mark as D.
6. Some places of existing floor of building were damaged. These place should be repaired.

7. Windows of building are not up to standard. Therefore, require to be changed by fixing louvers and removable mesh replacing grills.
8. Existing brought in cinnamon trees washing tanks were not suitable to proper operations of the factory. These tanks to be revamp and constructed at a suggested place in appropriate size and required finishes (e.g. interior walls tiled with large, gloss finished, glazed marble tiles).

9. Premised did not have a proper utility area to unload and draining excess water of cinnamon tree bundles before taken inside the factory. Recommended to build a utility area and required offloading platform in area marked as F and that to be concreted and cemented according to standard. Furthermore, this area to be demarcated with a half high boundary wall to restrict unauthorized access of workers.

12. Required racks, clock hangers, tables, stools, slippers, clocks, caps, drying towels, etc., for workers' and guests' hygiene in entering factory were lacking. These required materials and equipment to be provided.

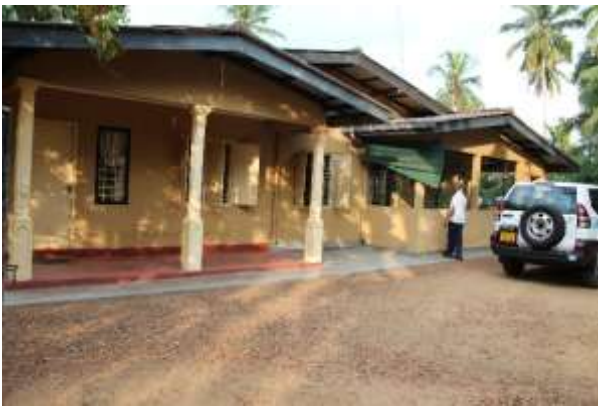
Figure 6. View of entrance to factory

1. Windows at front entrance area to be changed from wire mesh grills to sliding glass windows with louvers. Fix notice board on front entrance wall. Fix auto door-closure on slashes of door to enter to processing areas from front entrance. Remove wooden slashes, which are on just above foot bath area of front entrance and replace with sealed glasses. Foot bath in front entrance to be modified reducing width by filling up and fixing stainless steel hand rail to guide guests entering to processing areas.

2. Outer door of the entrance to be changed by fixing auto door-closure and top half of the slash fixed with glass and bottom to be fixed with a suitable sheet. Provide rubber and clothes mats at entrance for drying feet after immersing in foot bath.

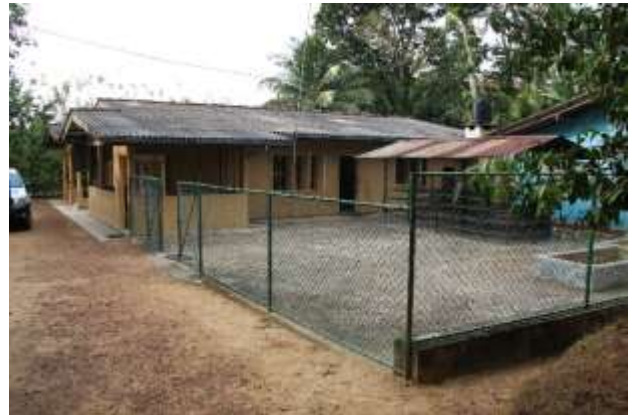
Figure 7. View of outdoor washing and drying area of factory

10. Replace center column tiles.
11. Gully of worker cleaning area that is in outside drying area to be repaired.
12. Washing tanks to be chipped off the existing plaster and tiling with large, gloss, and glazed marbles. Floor of outside drying area to be cemented for smooth finish. Boundary wall to be improved by constructing half wall and wire mesh the boundary.

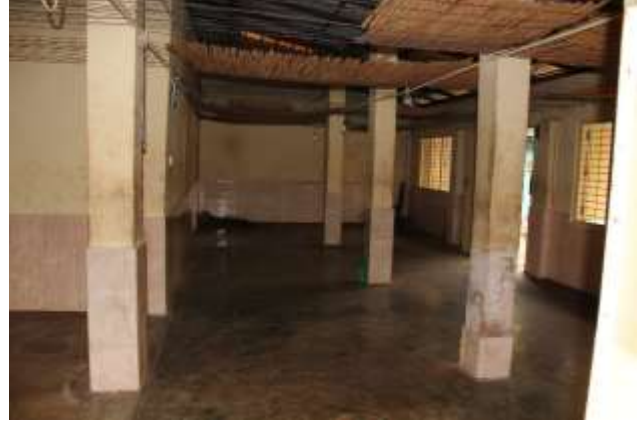
Figure 9. View of peeling and scrapping areas of factory

components for processing, worker changing and resting, and toilets. Critical physical requirements for food safety compliance were present. Boundary of premise was demarcated and physically separated from surrounding by a wire mesh fence. Basic facilities for workers were also present.

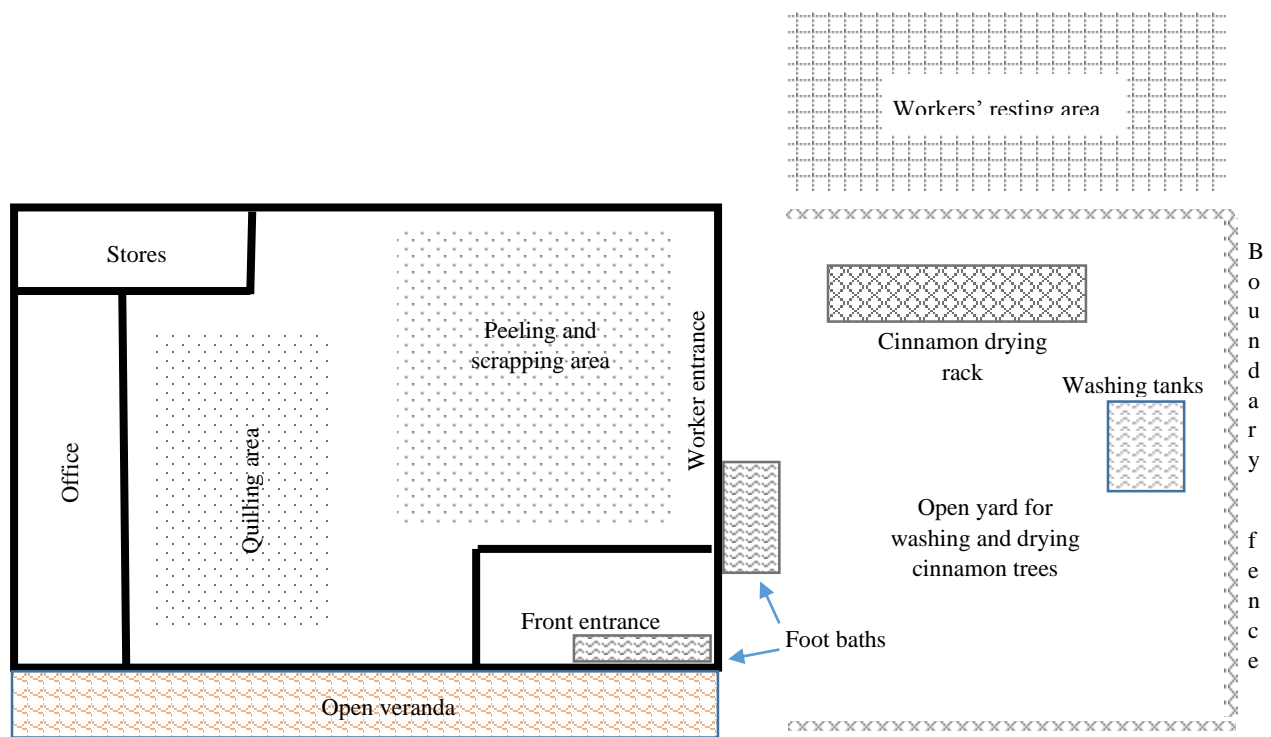
Figure 10. Sketch of factory layout (not drawn to scale)

All observations and recommendations are referring to Figure 10.

3. Provide fully covered plastic shades for lightings in processing areas.
4. Replace existing hand operated taps with foot operating taps at all wash basins.

5. Gap between wall brim and roof to be filled with wire mesh to prevent animals entering to processing areas.

6. Required racks, clock hangers, tables, stools, slippers, clocks, caps, drying towels, etc., for workers' and guests' hygiene in entering factory were lacking. These required materials and equipment to be provided.

7. Ceiling of premise to be built by using approved and suitable materials.
8. Colour washing of premise's walls.
9. Use rubber carpets to cover factory floor.

13. Gate to worker resting area from factory to be closed. 21' x 11' area to be demarcated at suggested position and fence with wire mesh and half wall in "L" shape to allow easy handling of cinnamon wood. A new gate (inlet) to be fixed at a suggested position and fix an unloading plat form.

14. Change the existing drying racks according standards.

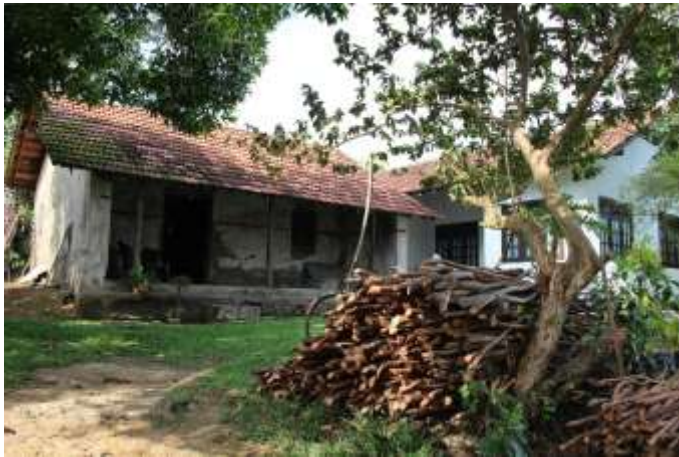
Figure 11. Front and lateral view of factory

A firmly built premise with physically separated components for processing areas. Critical physical requirements for food safety compliance were present, but not at expected operational level.

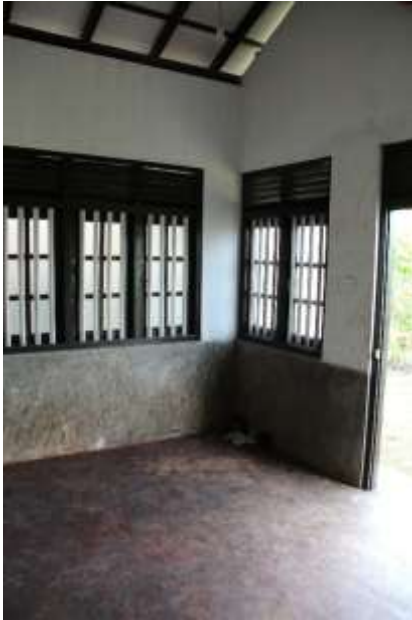
Figure 13. Scrapping section of factory

1. Size of existing scrapping section was not enough for effective work. Expansion of this section of building according to standards is needed.
2. There was no washing tank for factory. Build washing tank at suggested place.
3. Roof was incomplete. Fix gutters, drains, and skirting according to standards for completion.
4. The premise did not have electricity and pipe borne water supply, which support effective and efficient implementation of food safety measures. Obtain electricity to premise and plumbing to standard.
5. There was no boundary fence demarcating premise. Built boundary fence.
6. Door of store room of the factory was lacking a slash. This to be fixed.

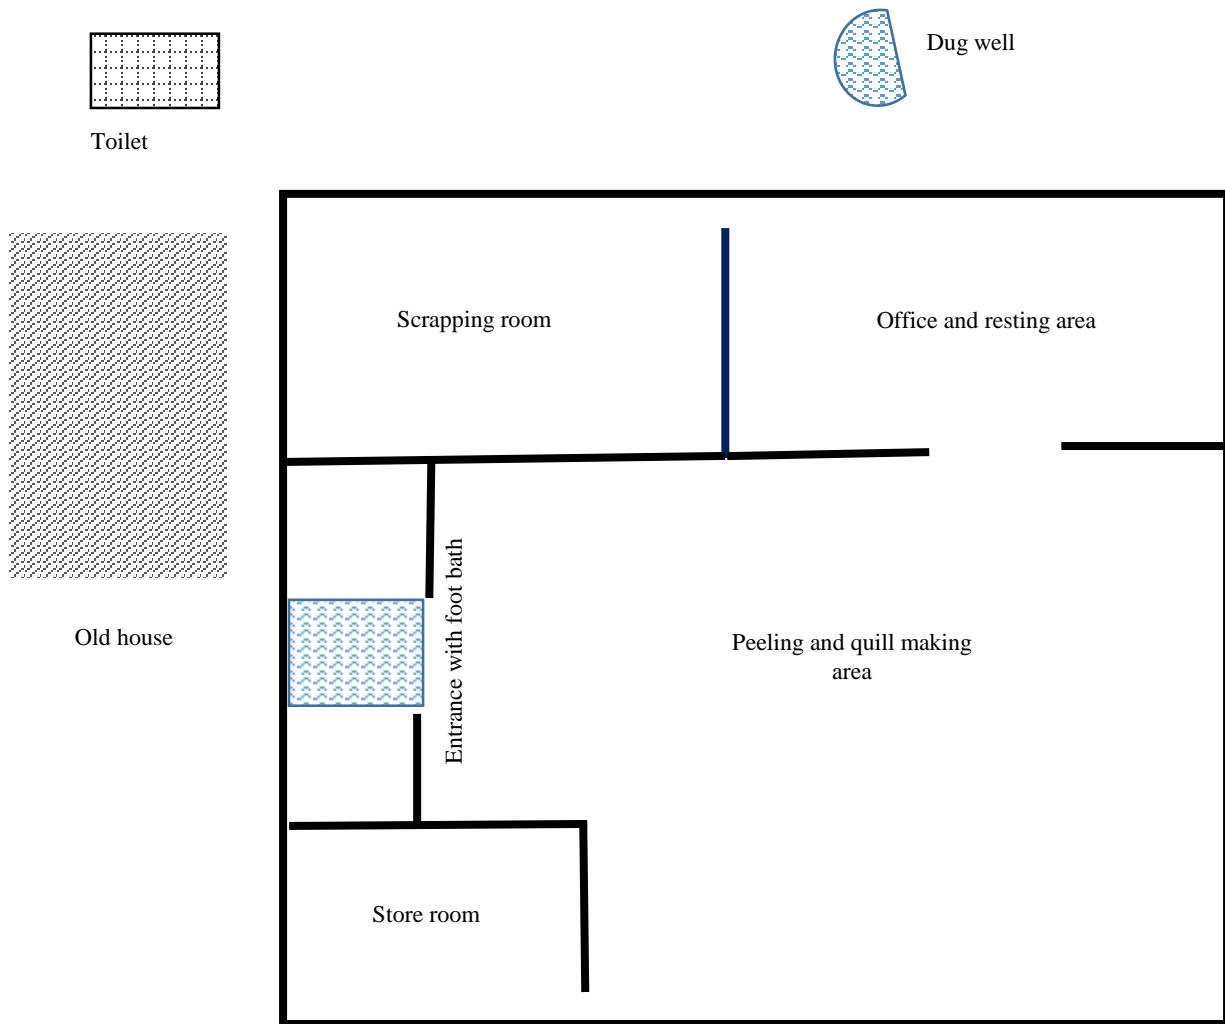
Figure 12. Factory lay out (a sketch no drawn to scale)

All observations and recommendations are referring to Figure 13.

7. Required racks, clock hangers, tables, stools, slippers, clocks, caps, drying towels, etc., for workers' and guests' hygiene in entering factory were lacking. These required materials and equipment to be provided.
8. Gap between wall brim and roof to be filled with wire mesh to prevent animals entering to processing areas.
